Cavity Wall Tie Repair

Cavity Wall Tie Failure

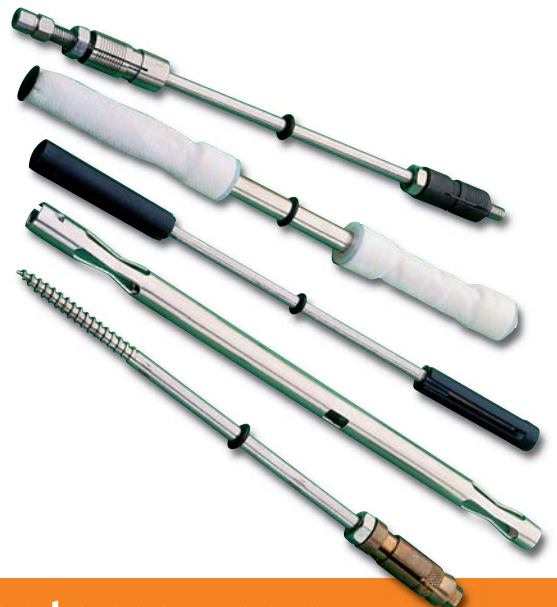
Solution

The first step in a repair programme is a survey to determine the extent of the problem. The position of existing wall ties is plotted using a metal detector and then an endoscope is used to examine their condition. Bricks may have to be removed for the physical examination of sample ties.

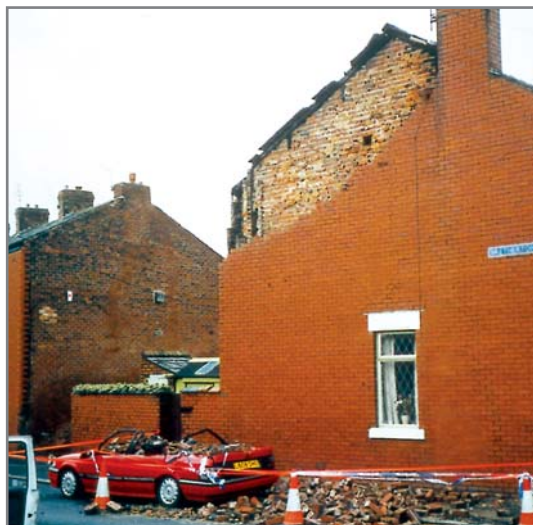
Exposed elevations of a building are more prone to problems as are industrial environments or marine locations with driving rain and salt laden atmospheres.

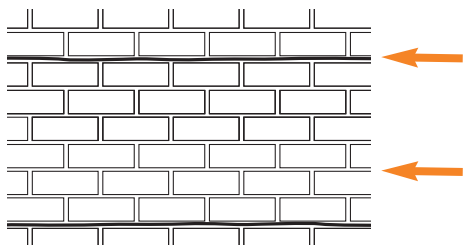
Horizontal Cracking

Corrosion of fishtail ties can result in horizontal cracks in external mortar joints at regular intervals of between 5 and 7 brick courses.

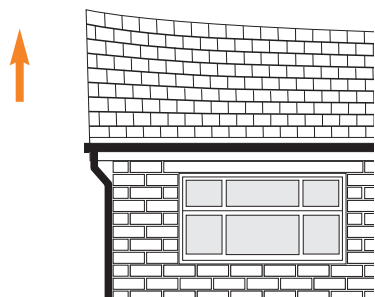
Lifting of Roof Edges

At gables the 'growth' of brickwork can lead to a 'Pagoda' effect.

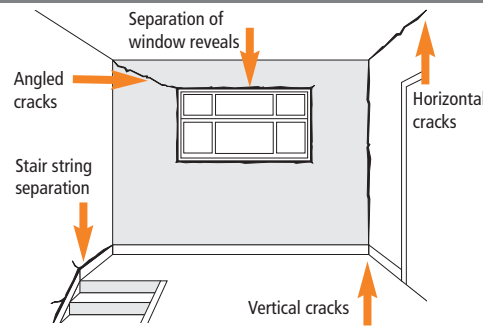
Internal Cracks and Finishes

Vertical cracks may be found at internal/external wall junctions and horizontal cracks appear at internal wall/ceiling joints.
